Alberta Transportation

Highway 2 at Township Road 204 Safety
Review

July 2019

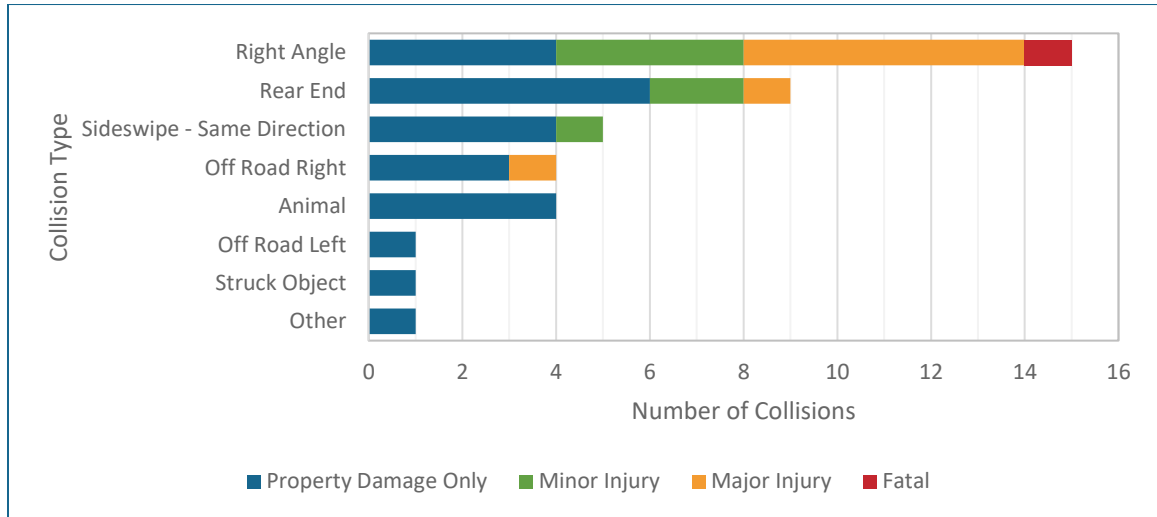
Figure 3: Summary of Collisions by Types and Severity (2012 to 2016)

- The prevalent collision types are “Right Angle” (37.5% of collisions) and “Rear End” (22.5% of collisions).
- Broken down by severity, the intersection experienced one (1) fatal, eight (8) major injury, seven (7) minor injury, and 24 property damage only (PDO) collisions.
- Almost half of the “Right Angle” collisions were fatal or major injury severity.
- Four (4) animal collision occurred at the intersection. Animal and non-animal collisions are analyzed separately for the remainder of the discussion as the causes of animal collisions are different from the other collision types.

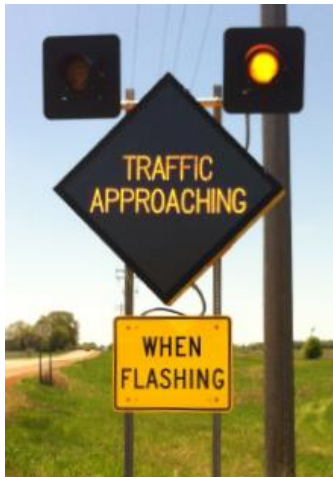
Intersection Conflict Warning System for TR204 Estimated Cost: \$200,000 (NOT RECOMMENDED)

ISL does not recommend implementation of a Intersection Conflict Warning System for TR204 based on the high traffic volumes on Highway 2 resulting in reducing potential for the system to identify suitable gaps, the risk associated with drivers becoming reliant on the system to make decisions to enter the intersection and the potential for system malfunction and/or power outage.

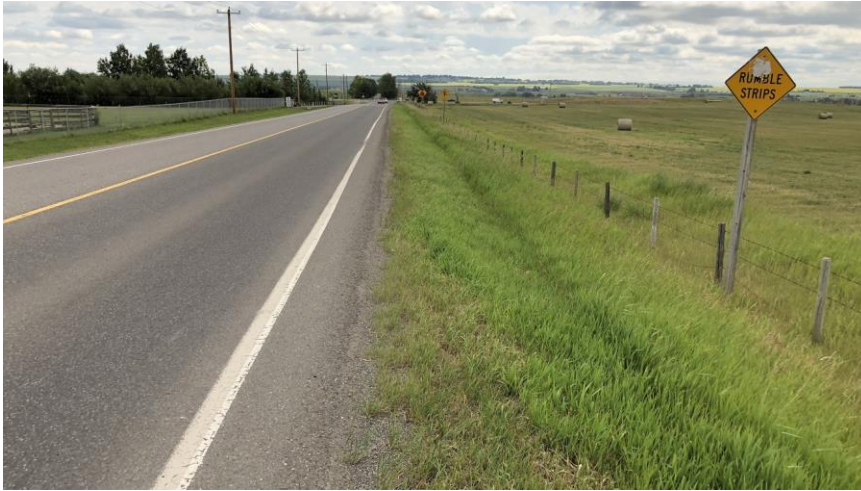
Looking toward the intersection from the Rumble Strips sign on the west approach.

The Rumble Strips sign has significant damage (shotgun damage) to the sign face.

- The Rumble Strips sign has significant damage (shotgun damage) to the sign face. The sign is only partially legible.
- The transverse rumble strips in advance of the Stop sign are worn in the wheel paths.

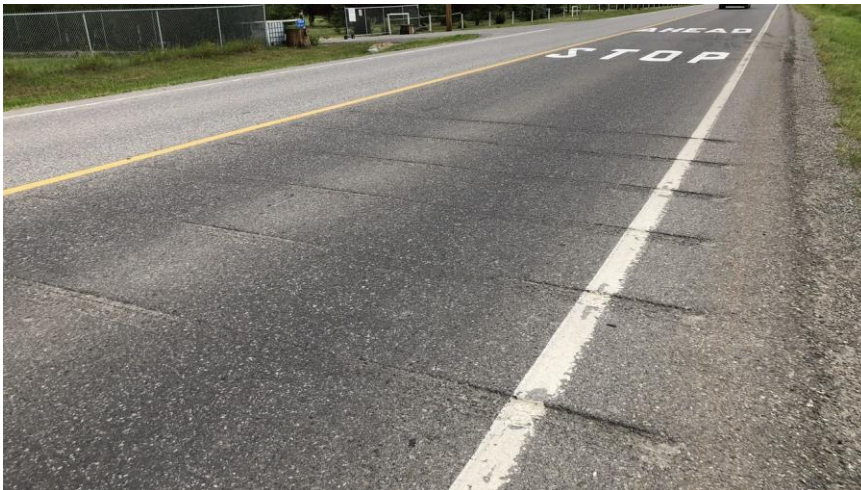
Transverse rumble strips on the west approach are worn in the wheel paths.

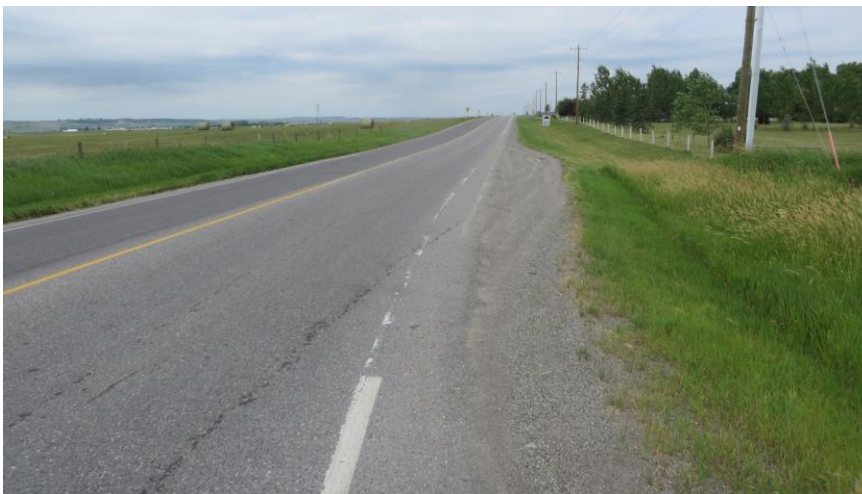
Looking west towards the west approach from intersection.

There is evidence that vehicles have been pulling off the pavement and stopping on the north shoulder.

- **Queuing on West Approach:** Queue lengths of up to four (4) vehicles were observed at the eastbound stop line.
- **Vehicles Stopping on TR204 Shoulder:** There is evidence that vehicles pull off the pavement on the north shoulder of the west approach. One vehicle was observed pulled over in this area during the site visit. The roadside geometry at this location (0.6 m paved shoulder and ~4:1 side slope) is not adequate to accommodate stopped vehicles.
- **Memorial Marker:** Flowers were attached to the eastbound Stop Line sign and nearby street light pole, and appear to be a memorial marker.

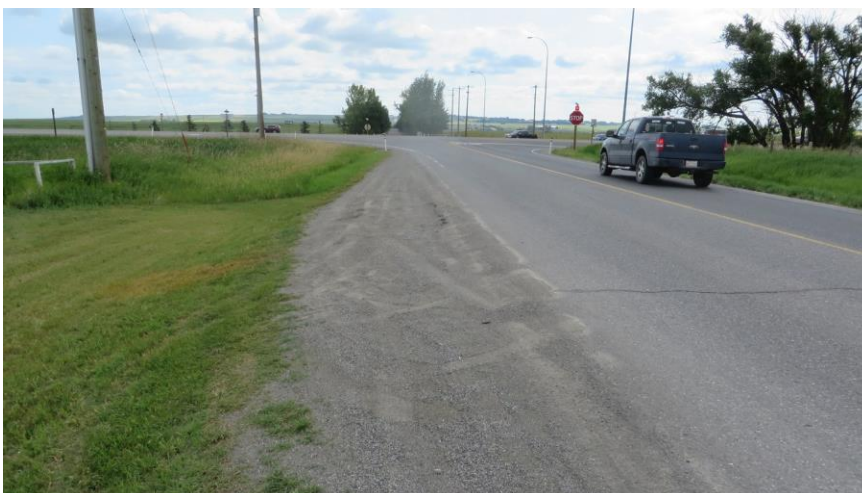
Looking towards the intersection from the west approach.

There is evidence that vehicles have been pulling off the pavement and stopping on the north shoulder.

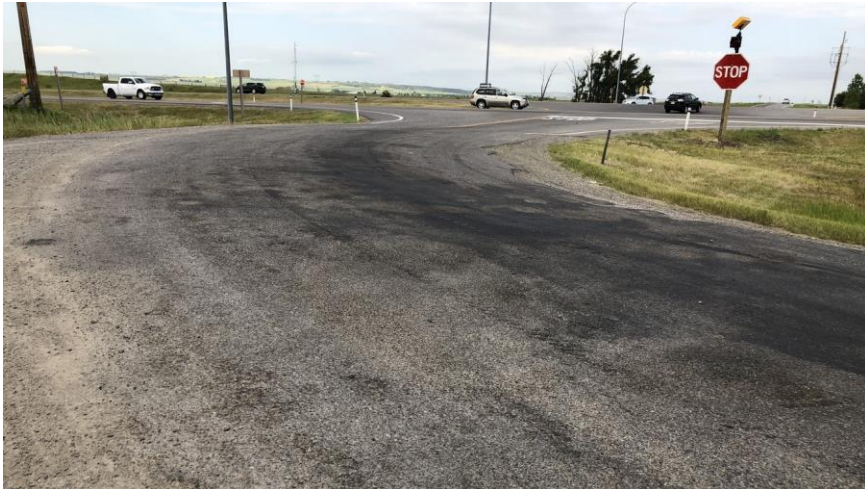
Looking southwest toward the intersection from the bend on the east approach.

Pavement deterioration is evident along the inside of the bend and the area adjacent to the pavement appears to be heavily travelled.

- **90° Bend:** Pavement deterioration is evident on the 90° bend between the north and west legs of the TR204/TR290 intersection, especially along the inside of the bend. The area adjacent to the pavement appears to be heavily travelled.

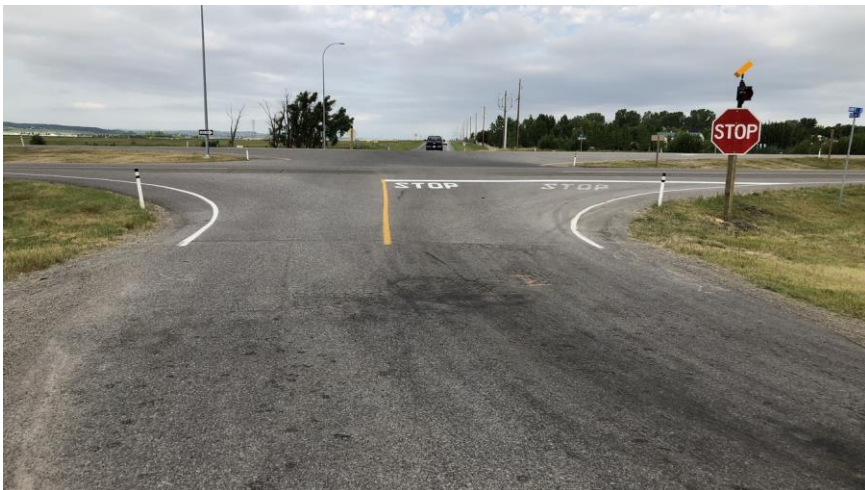
Looking toward the intersection from the east approach.

The right STOP word marking is fading.

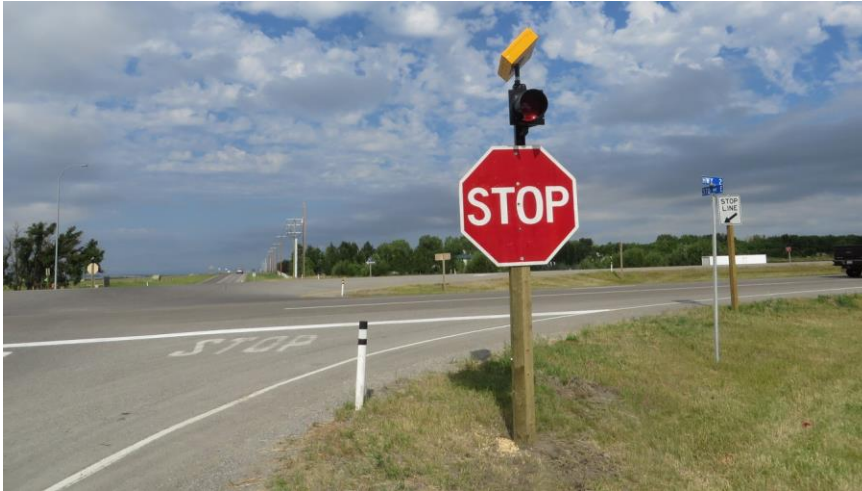
The Stop sign and flashing red light on the east approach.

The Stop sign is installed on a double-wide wood post that appears to have been installed recently.

- The westbound Stop sign is oversize (1,200 mm by 1,200 mm) and is supplemented with a flashing red light and a Stop Line sign. The Stop sign is installed on a double-wide wood post that appears to have been installed recently.
- The Stop Line sign is bent and has minor damage (scuff marks) to the sign face. The sign is still legible.
- The stop line and left STOP word marking are in good condition.
- The right STOP word marking is fading.
- The centreline and edge line markings are in good condition and terminate near the highway right of way boundary.
- The Bidirectional Checkerboard sign has minor damage (flaking) to the sign face. The sign is still legible.
- The Stop Ahead sign has minor damage (flaking) to the sign face. The sign is still legible.
- Rumble strips were not identified for this approach.

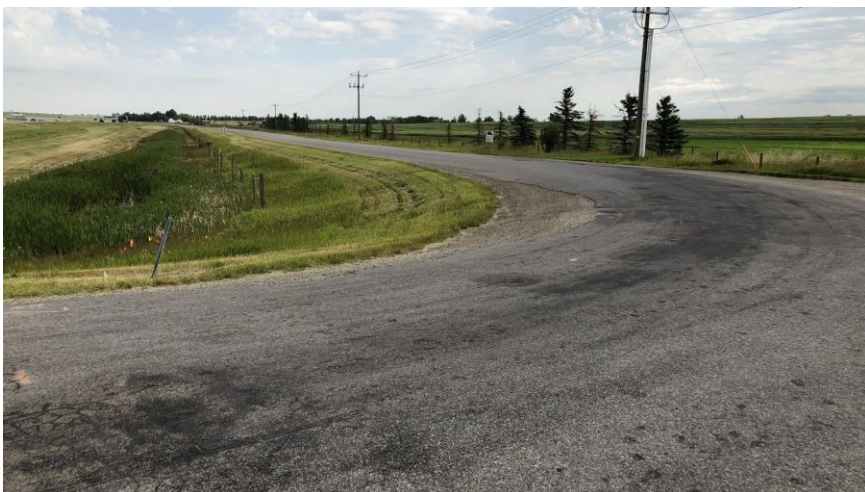
Looking north from the TR204/RR291 intersection.

The intersection is uncontrolled and the north and west legs operate as a single continuous route with a 90° bend.

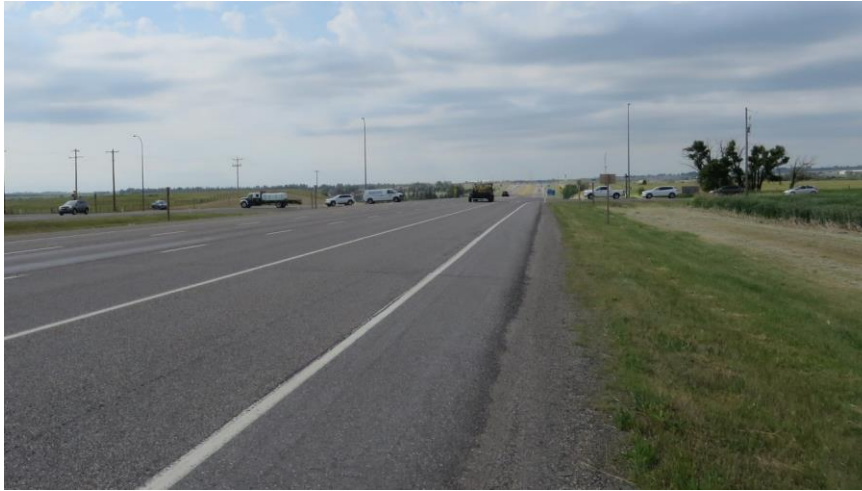
Looking towards the intersection from the north approach.

A queue of four (4) vehicles on the west approach wait for vehicles in the median opening to clear.

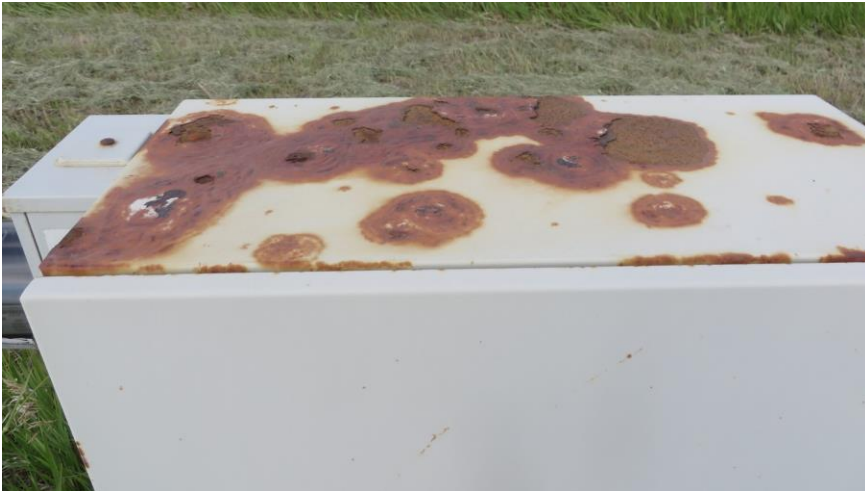
Rust on top of the illumination system PDC.

- **Pole Condition:** All street light poles appeared to be galvanized and in good condition.
- **Operational Check:** The photocell in the PDC was covered temporarily during the site visit to check the operation of the lighting system. The lighting system operated without issue.
- **PDC Condition:** The top of the PDC is rusting. The access louvre on north side of PDC is off and lying in grass at the base of the PDC.

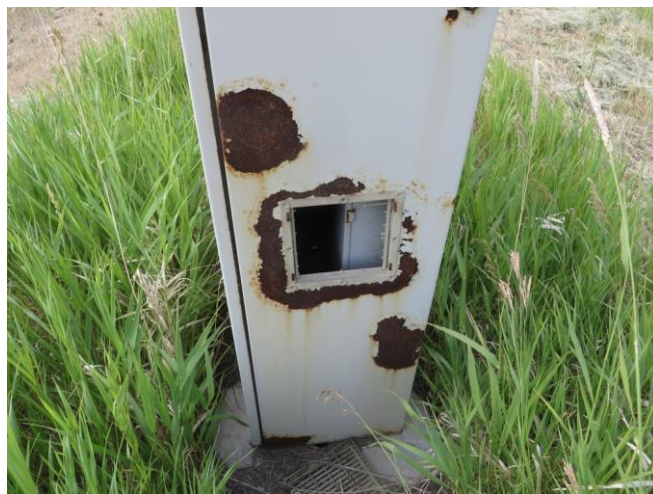
Missing access louvre on the side of the illumination system PDC.
