Alberta Transportation

Highway 2 at Township Road 210 Safety Review

July 2019

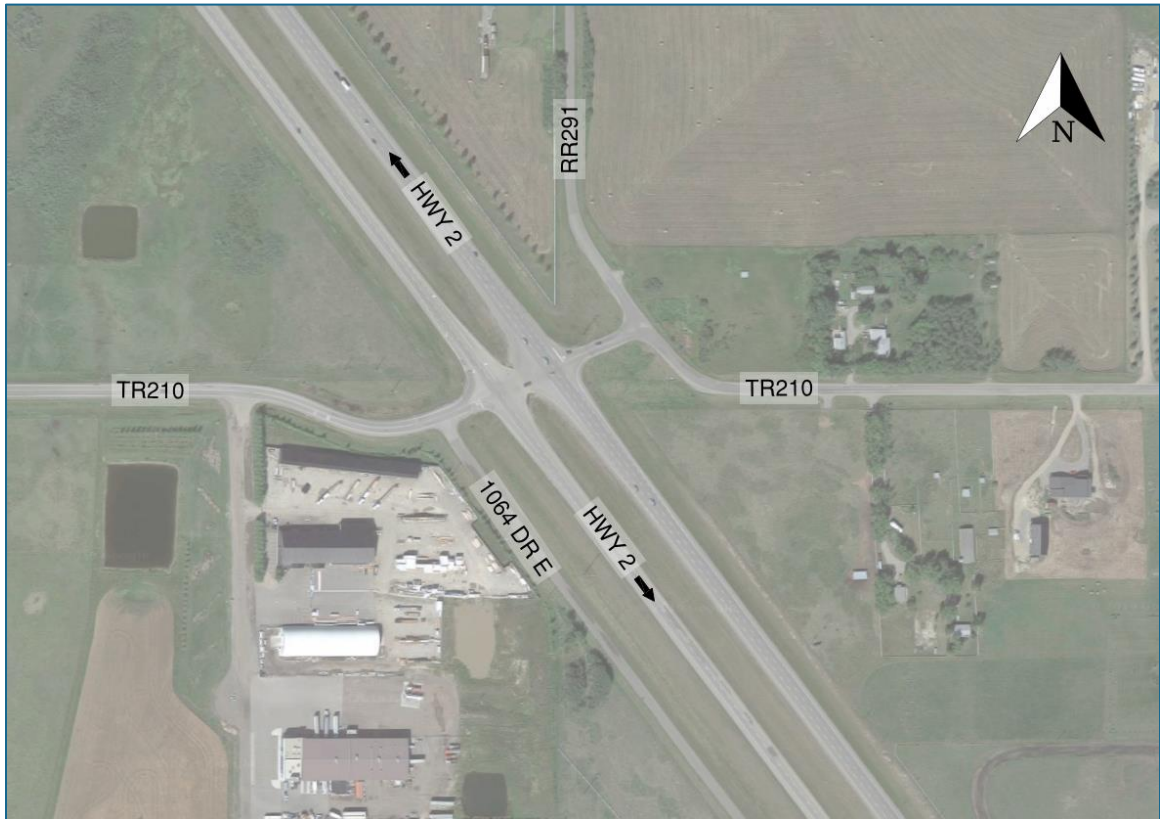
Figure 1: Highway 2:12 at TR210 Intersection

East of Highway 2, TR210 is a paved rural two-lane undivided roadway with a statutory 80 km/h speed limit. TR210 intersects with RR291 in a “T” configuration centred approximately 74 m east of the northbound Highway 2 centreline.

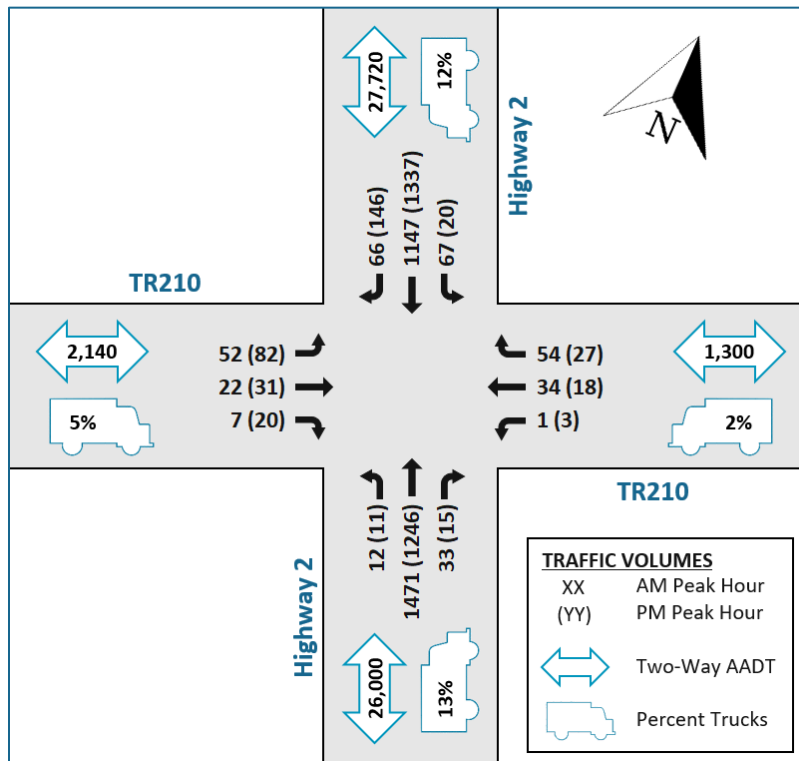
Figure 2: 2018 Traffic Characteristics

Traffic characteristics for the TR210 intersection are presented in Figure 2 and include:

- Annual Average Daily Traffic (AADT);
- percent trucks (including RVs and buses); and
- AM and PM 100th highest hour turning movement estimates.

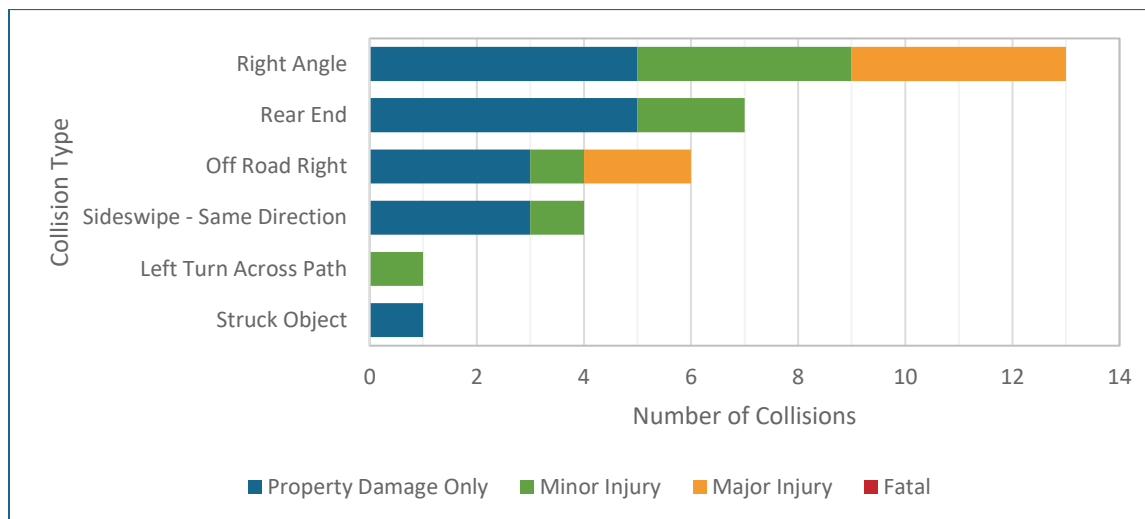
Figure 4: Summary of Collisions by Types and Severity (2012 to 2016)

- The prevalent collision types are “Right Angle” (40.6% of collisions) and “Rear End” (21.9% of collisions).
- Broken down by severity, the intersection experienced six (6) major injury, nine (9) minor injury, and 17 property damage only (PDO) collisions.
- Over half (61.5%) of the “Right Angle” collisions were major or minor injury severity.
- There were no fatal collisions at the intersection.
- There were no animal collisions at the intersection.

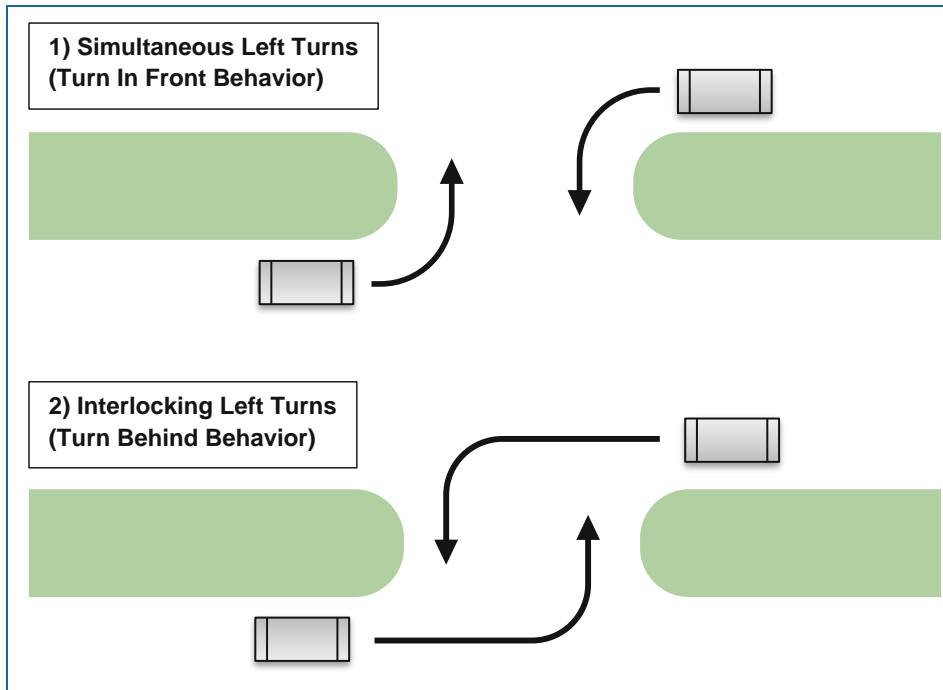
Figure 9: Opposing Left Turn Behavior (Source: Adapted from NCHRP Report 650)

- **Left Turn Vehicle Behavior:** Left turn vehicles were observed entering and travelling through the median opening along different paths. When left turn vehicles from opposite directions entered the median opening together, they were observed turning in front of one another (simultaneous left turns) or behind each other (i.e., interlocking left turns) as illustrated in Figure 9.

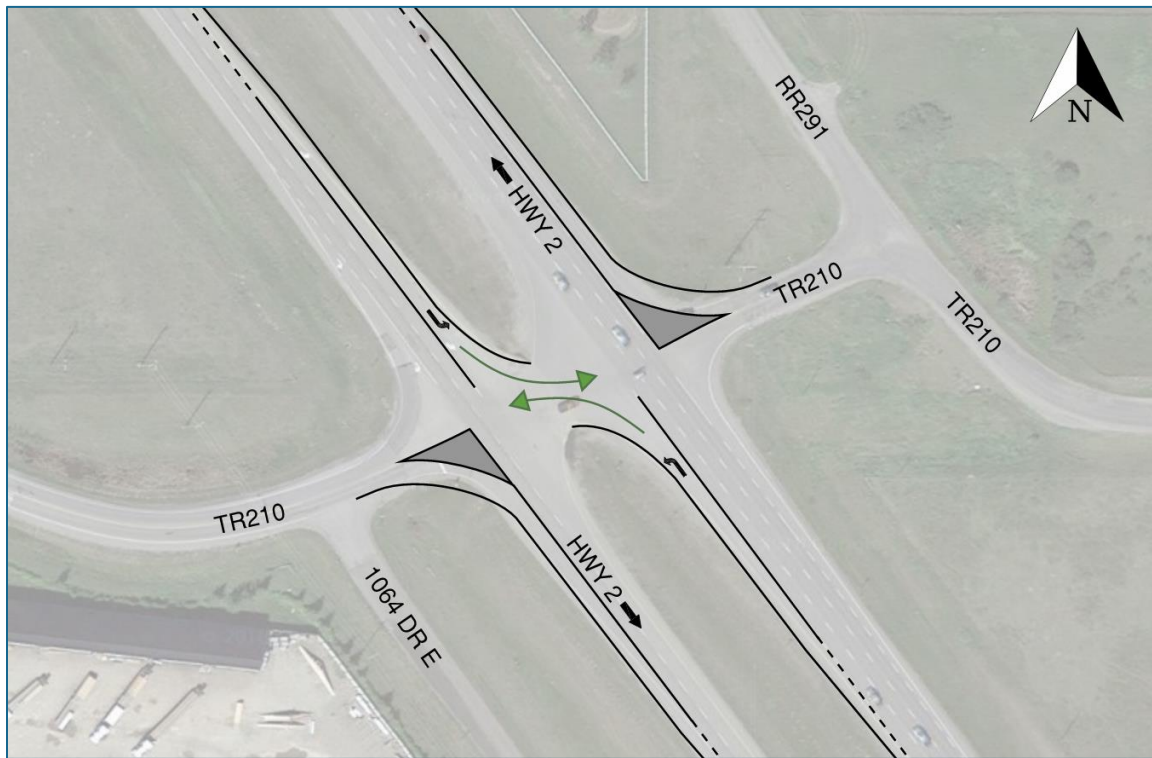
Figure 12: Turn Restrictions Using Divisional Island on Minor Approaches

- Develop divisional islands on the minor approaches to restrict left turn and through movements from the minor approaches while continuing to allow left turns from Highway 2 (Figure 12).
- Convert the existing median opening to a directional median opening that allows left turns from Highway 2 while restricting minor approach left turn and through movements (Figure 13).

The result of both of these options is that the minor approaches would operate as right-in, right-out and the left turns from Highway 2 would continue to be allowed. With no conflicting movements in the median opening, an additional 15 to 20 m would be available for left turn vehicle storage, however, to meet AT guidelines, the parallel lane lengths would need to be extended by 65 m for the southbound left turn lane and 45 m for the northbound left turn lane.

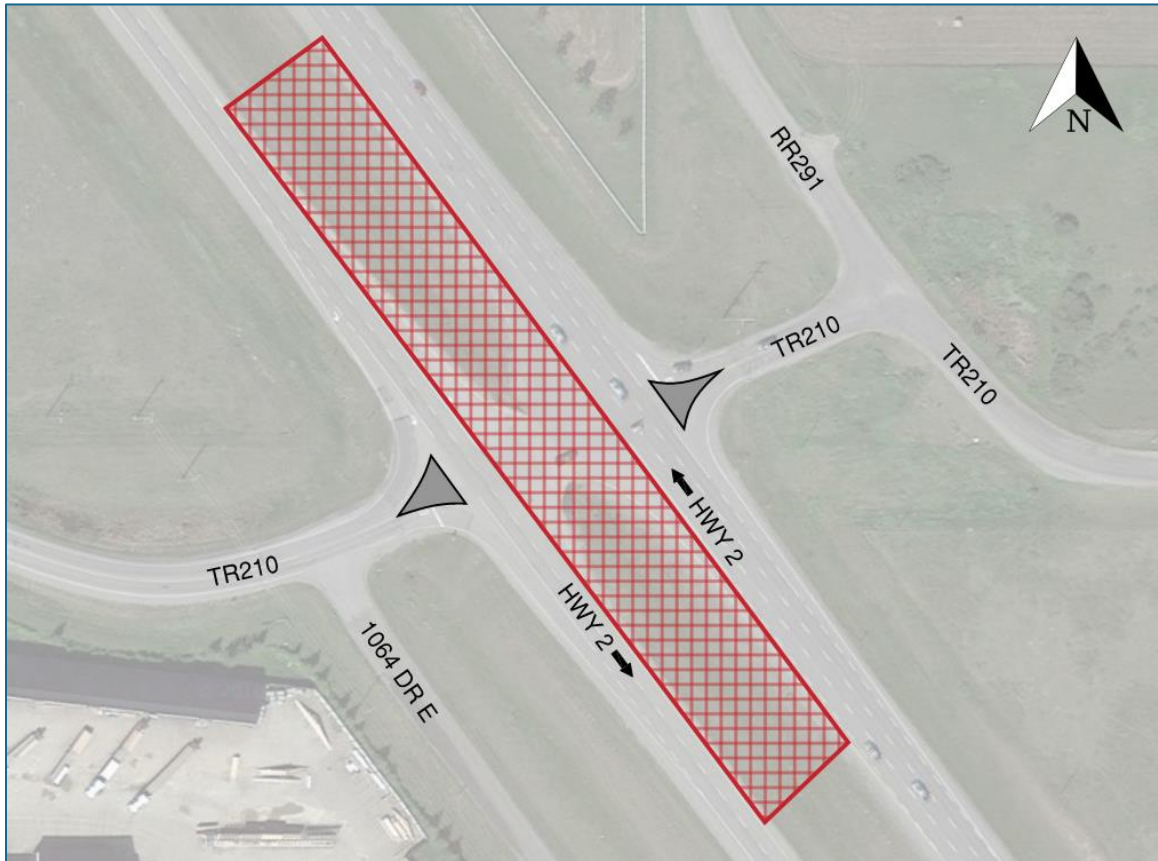
Figure 14: Full Median Closure

This option would restrict left turns on Highway 2 approaches as well as left turn and through movements on the TR210 approaches. Turn restrictions would be accomplished with complete closure of the median opening, and a painted right-in, right-out divisional island on the minor approaches. A sketch of the full median closure option is provided in Figure 14.

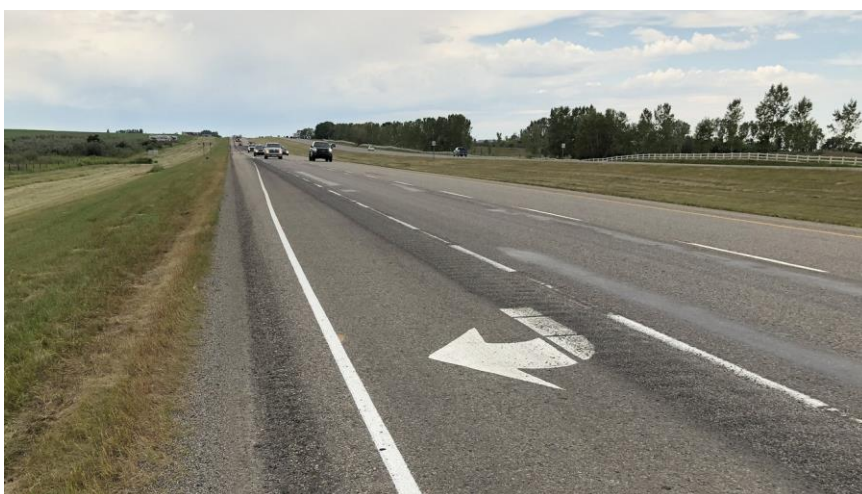
Looking north from the north approach right turn lane.

It appears that the length of the southbound right turn lane may have been extended recently using the existing paved shoulder.

- **Southbound Right Turn Deceleration Lane:** It appears that the length of the southbound right turn lane was recently extended using the existing paved shoulder. As no pavement widening occurred, the deceleration lane shoulder is narrow (less than 0.3 m).
- **Pavement Condition:**
 - Pavement deterioration is evident on the south edge of the west approach and the adjacent area appears to be heavily travelled. At this location, the edge of lane coincides with the edge of asphalt.
 - Tire tracks and pavement deterioration were observed along the south edge of the median opening west of the bullet nose.
- **Memorial Marker:** A memorial marker for a 2011 fatal collision is located on the northeast corner of the intersection, just north of the Stop sign.

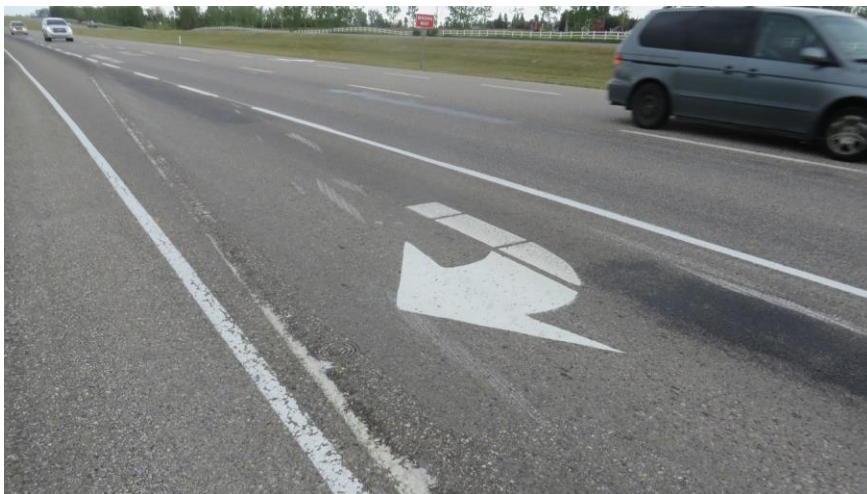
Looking north from the north approach right turn lane.

Note that the painted lines from the prior right turn lane configuration were partially visible.

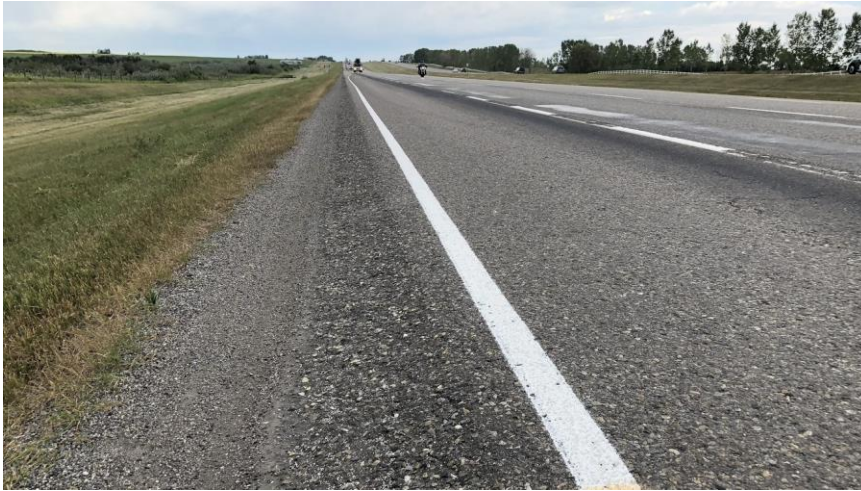
Looking north from the north approach right turn lane.

Note that the shoulder for the deceleration lane appears to be narrow (less than 0.3 m).

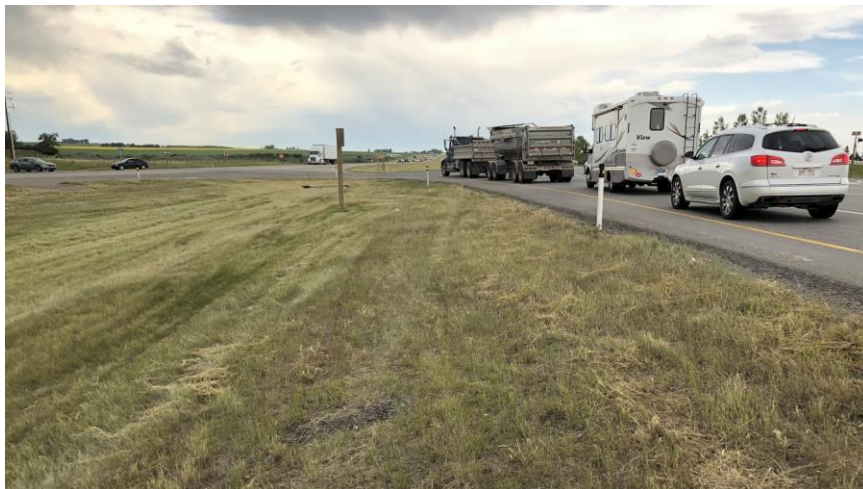
At this moment, three (3) vehicles were queued in the northbound left turn lane.

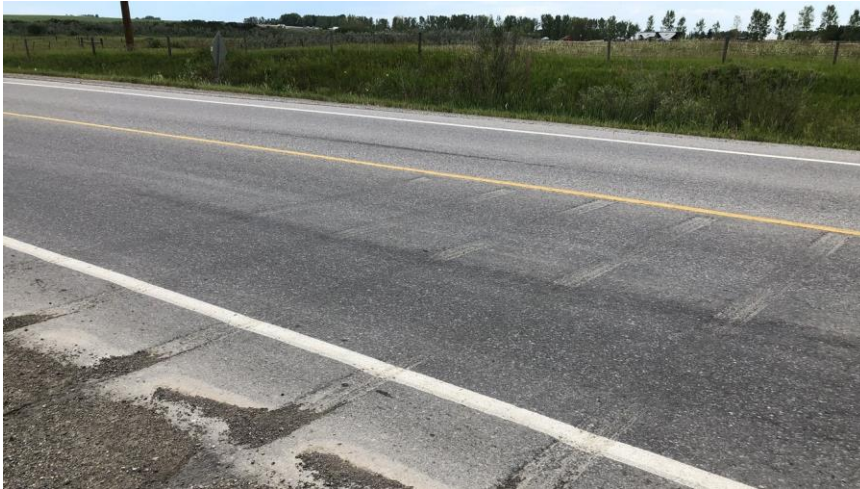
Transverse rumble strips on the west approach are worn in the wheel paths.

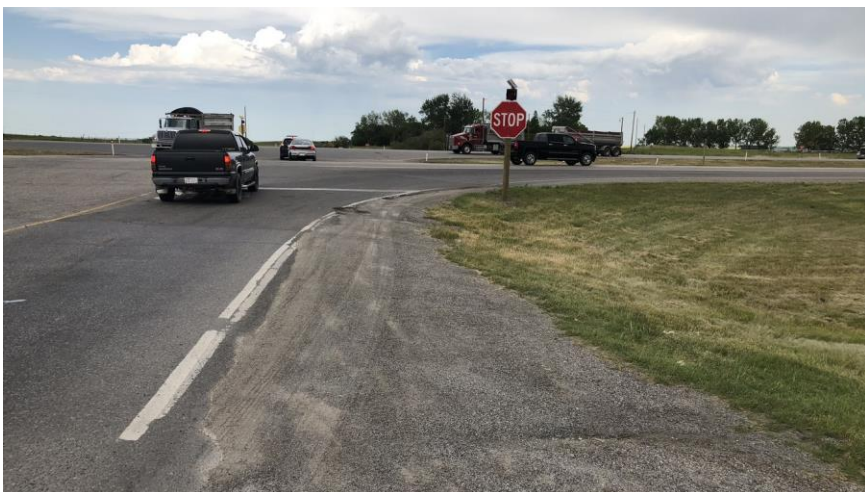
Looking toward the intersection from the west approach.

Pavement deterioration was evident on the south edge of the west approach and the adjacent area appeared to be heavily travelled.

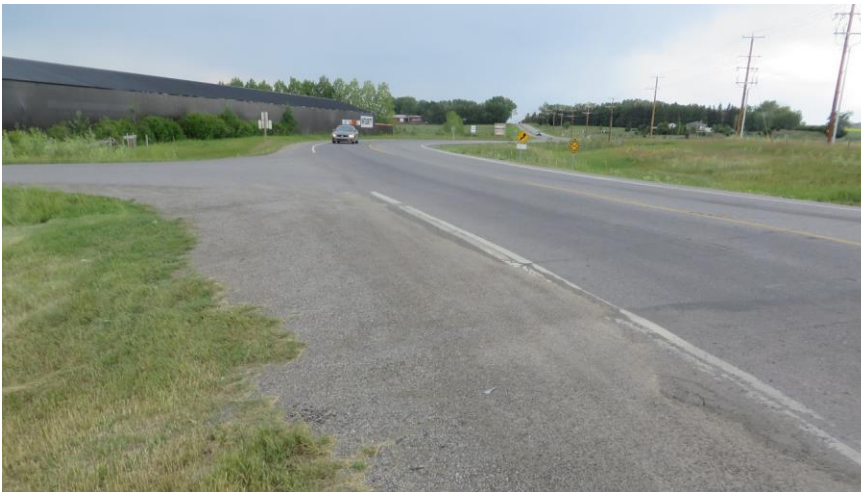
View west of the TR210 and 1064th Drive E intersection.

The south edge of TR210 appeared to be heavily travelled from 1064th Drive E to Highway 2.

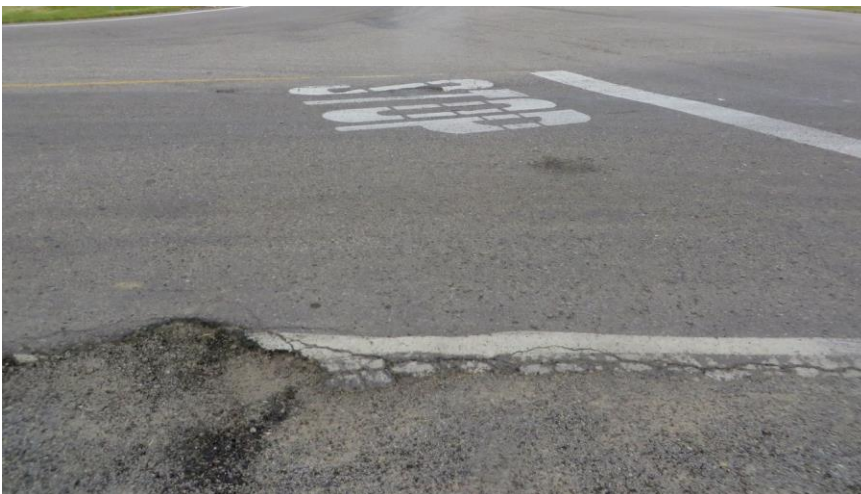
Pavement deterioration on the south edge of the west approach.

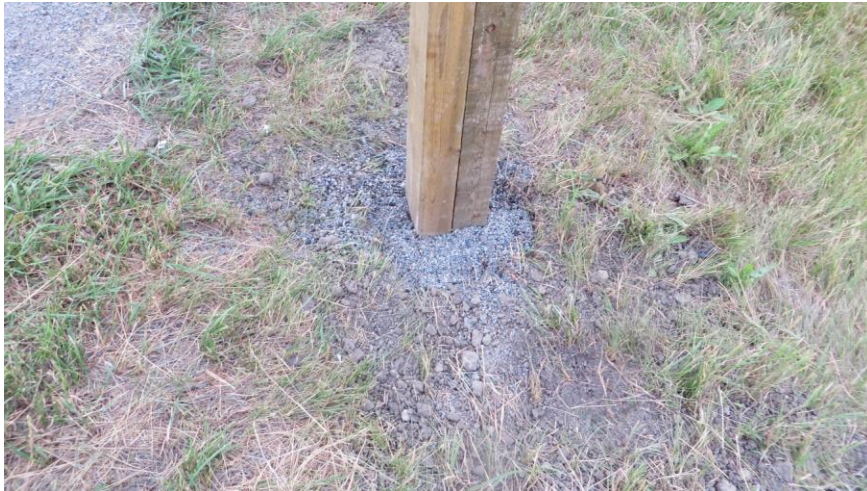
The double-wide post for the Stop sign and flashing red light on the west approach.

The post appeared to have been installed recently.

- The eastbound Stop sign was oversize (1,200 mm by 1,200 mm) and supplemented with a flashing red light. The Stop sign was installed on a double-wide wood post that appeared to have been installed recently.
- The stop line and Stop word marking were in acceptable condition.
- The edge line along the eastbound right turn radius was worn.
- The STOP AHEAD word marking was in excellent condition.

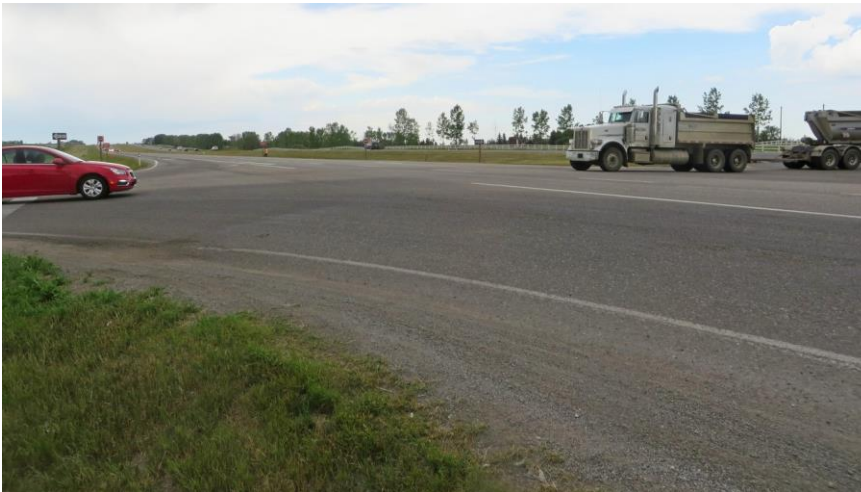
View of a vehicle stopped on the west approach.

Note that the vehicle on the west approach had pulled forward past the stop line.

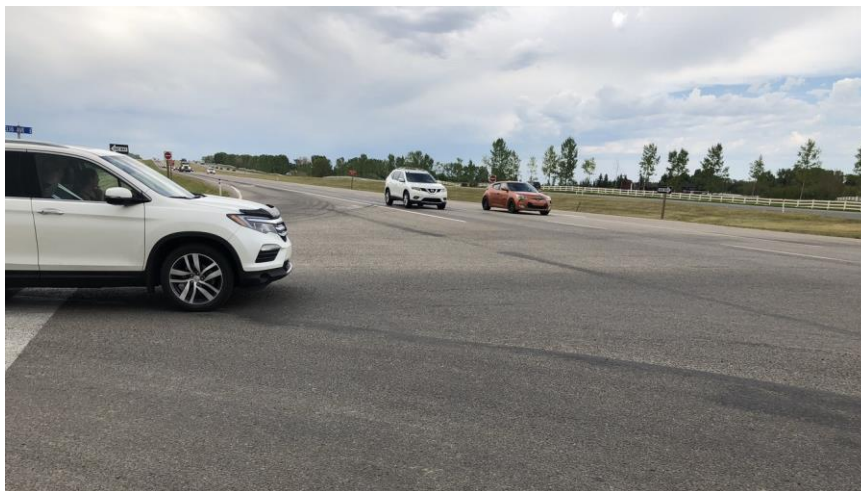
View of a vehicle stopped on the west approach.

Note that the vehicle on the west approach had pulled forward past the stop line.

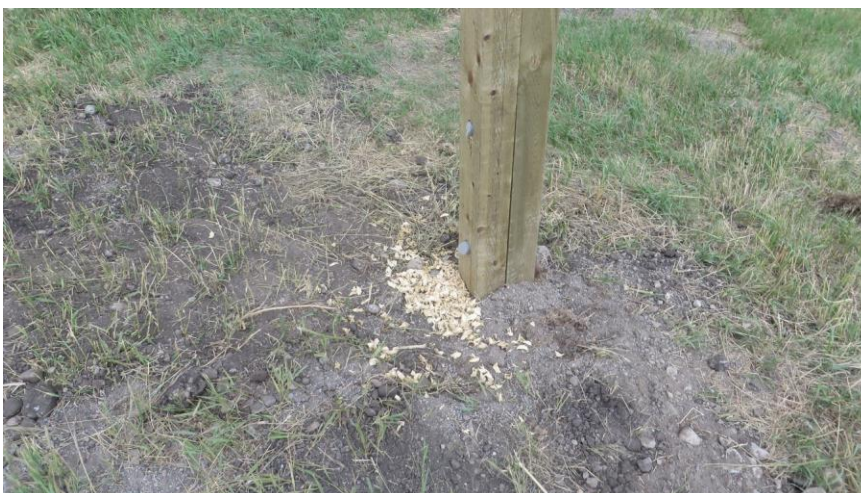
The double-wide post for the Stop sign and flashing red light on the east approach.

The post appear to have been installed recently.

- The westbound Stop sign was oversize (1,200 mm by 1,200 mm) and supplemented with a flashing red light. The Stop sign was installed on a double-wide wood post that appeared to have been installed recently.
- The stop line and Stop word marking were in good condition.
- The edge line along the westbound right turn radius was worn.
- Rumble strips were not identified for this approach.

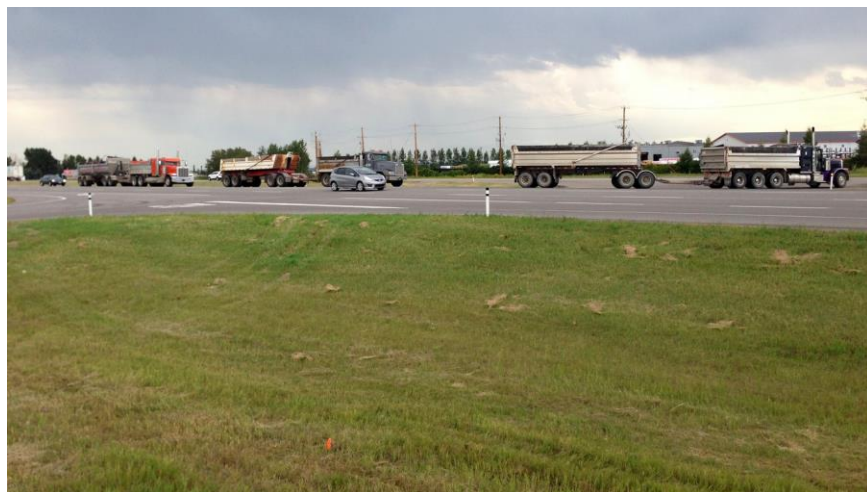
Looking towards the intersection from the northeast corner of the intersection.

At this moment, the queue length for the northbound left turn lane included four (4) vehicles including three (3) trucks.

During the site visit, a high volume of trucks were observed turning at the intersection.

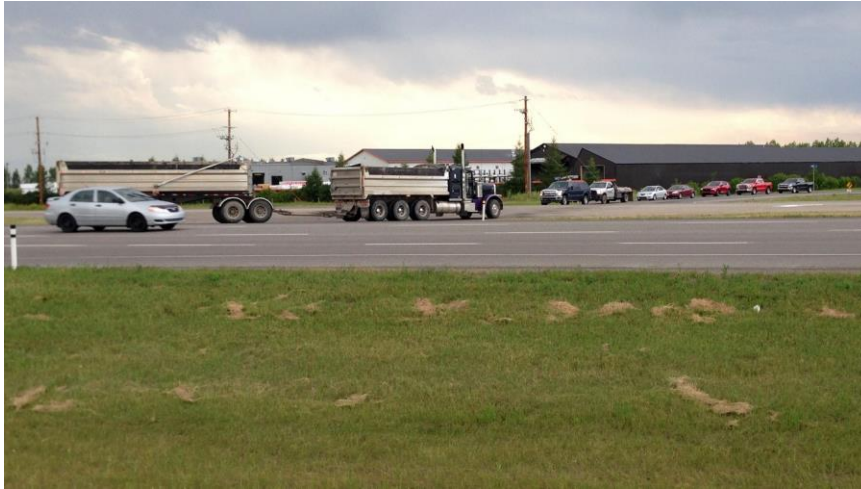
Looking towards the intersection from the northeast corner of the intersection.

At this moment, the queue length on the west approach included seven (7) vehicles.

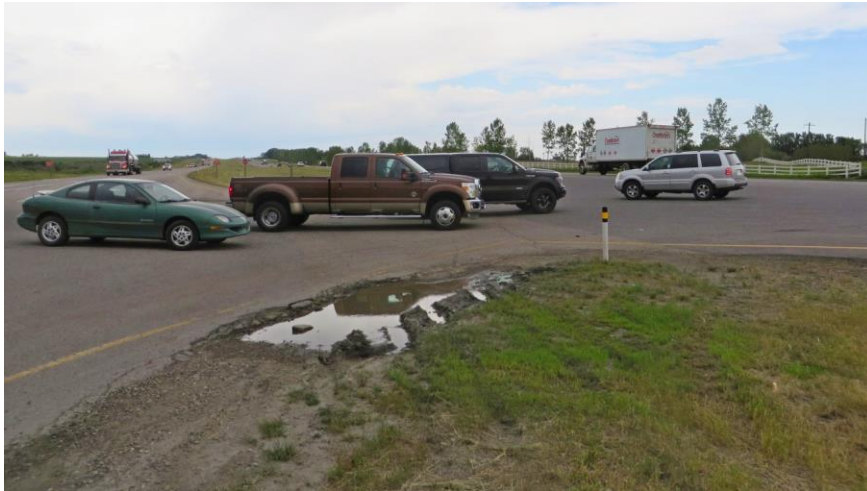
Looking north at the median opening.

At this moment, some vehicles had pulled in to the median opening at an angle to fit in the available space.

- The median opening experienced significant congestion during the PM peak hour. Vehicles entering the median opening were observed queueing side-by-side or pulling in at an angle behind a vehicle stopped in the median to fit in the available space. Up to three (3) passenger vehicles were observed stacking in the median opening when entering vehicles pulled in at an angle behind other stacked vehicles.

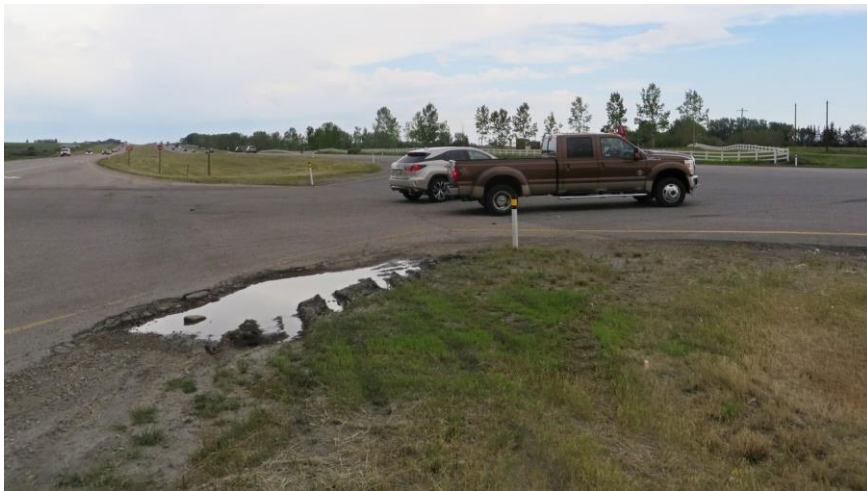
Looking north at the median opening.

Side-by-side queuing was observed in the median opening.

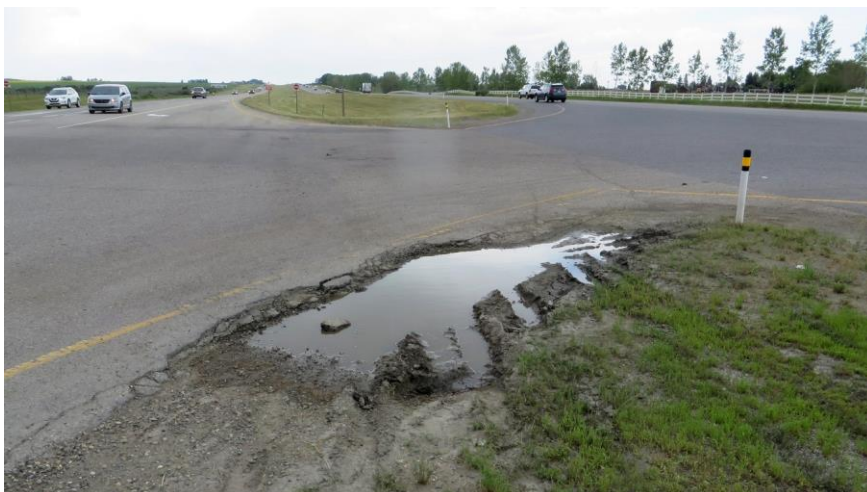
Looking north at the median opening.

Deterioration was evident on the south edge of pavement in the median opening.

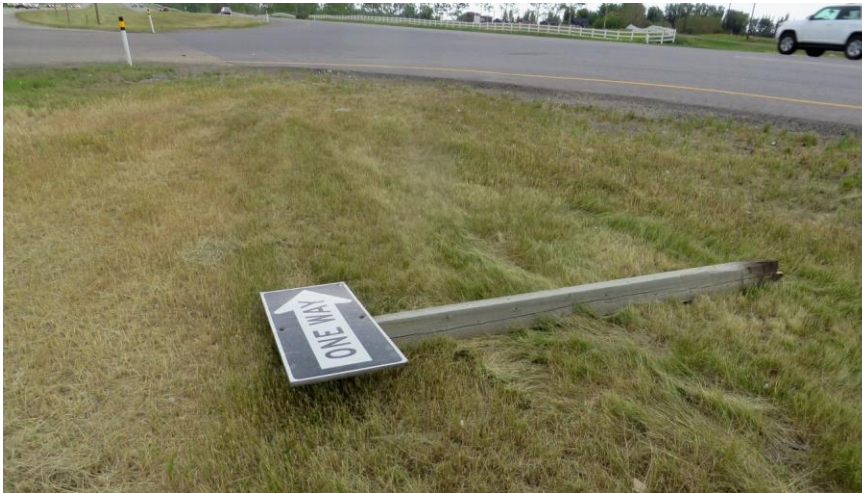
The One Way sign in the median beside the northbound left turn lane was knocked over.

- The Wrong Way sign on the median side of the northbound lanes was bent. The sign was still legible.
- The One Way sign on the median side of the northbound lanes was knocked over.
- The One Way sign on the outside edge of the northbound lanes was bent. The sign was still legible.
- Pavement markings for the northbound lanes of Highway 2 were in good condition.
- Centreline and shoulder rumble strips terminated in advance of the tapers and were in good condition.

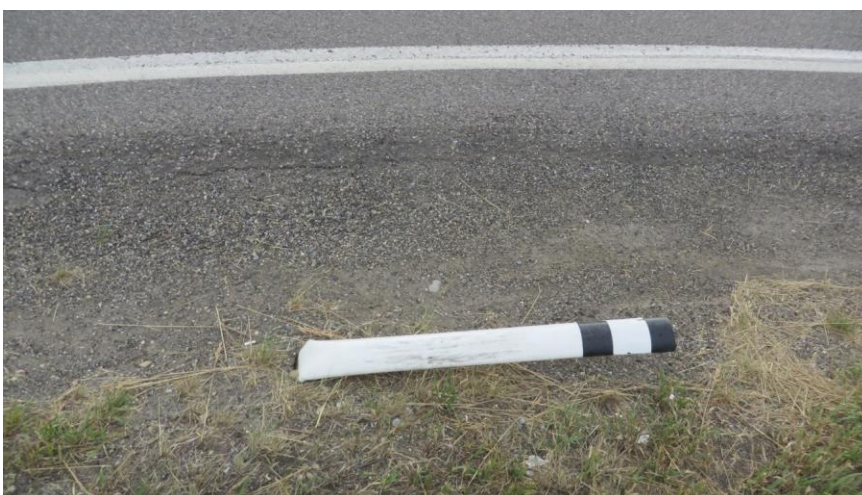
A delineator guide post beside the southbound right turn radius was bent over / flattened.

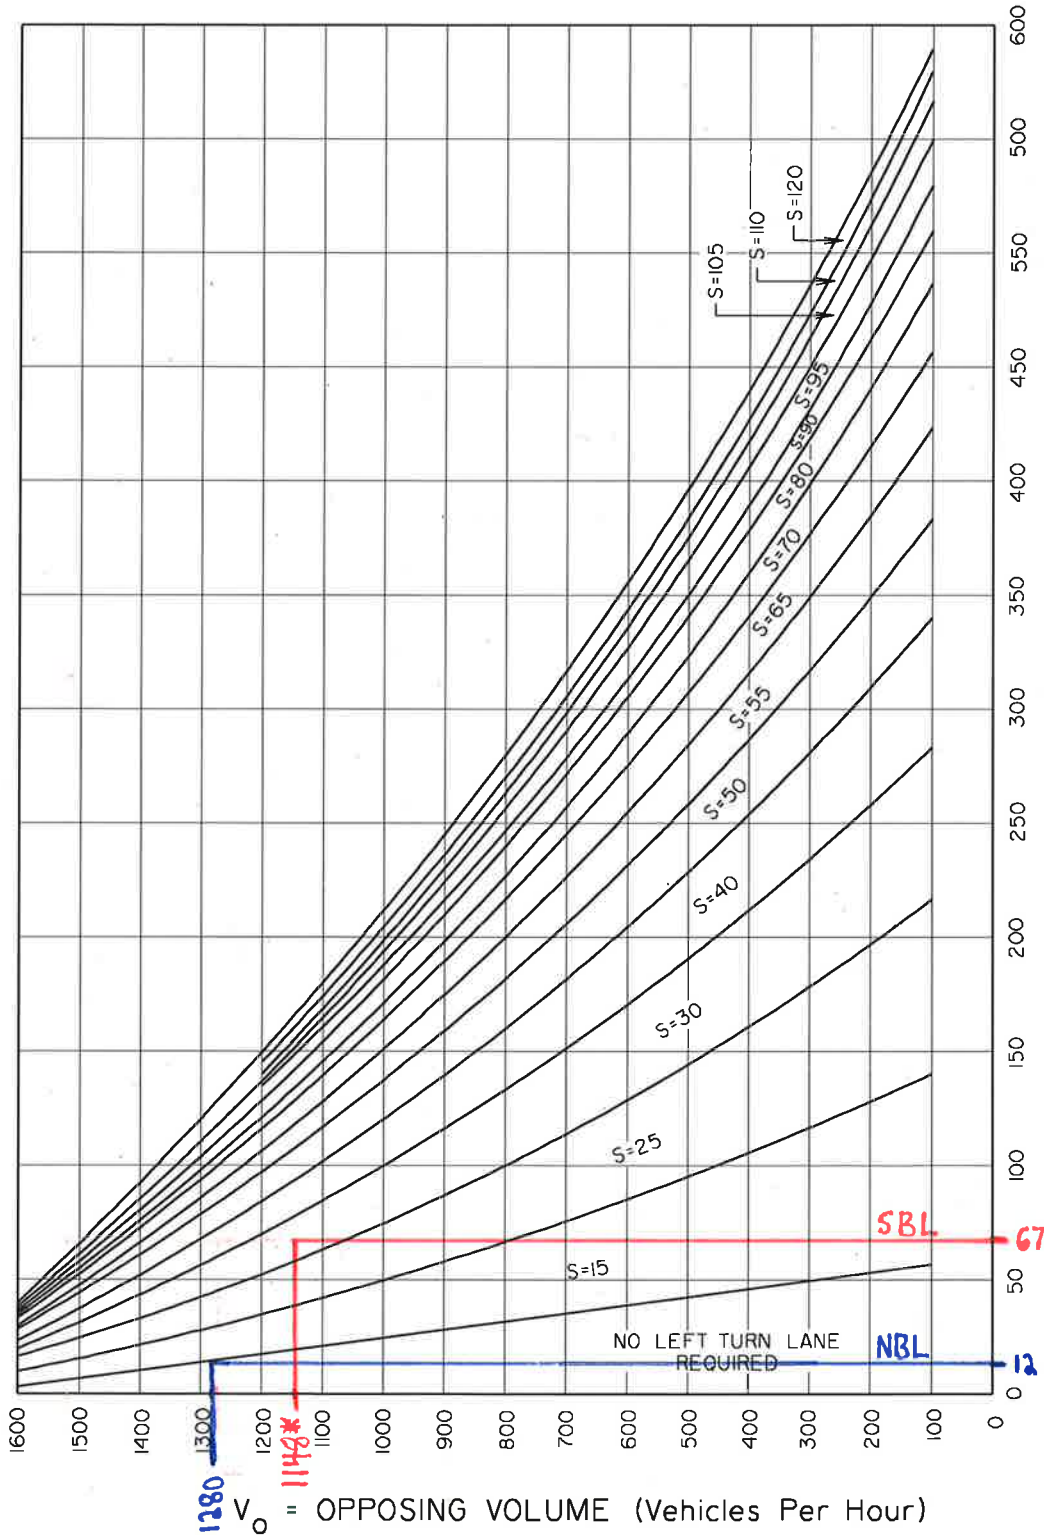
FIGURE D-8.6c WARRANTS FOR LEFT TURN LANES AND STORAGE REQUIREMENTS FOR FOUR-LANE DIVIDED HIGHWAYS

* Adjusted opposing volume for SBL as the left turns cross 3 lanes and the chart is based on left turns crossing 2 lanes. Adjusted opposing volume to only include through volumes from the 2 right-most through lanes plus the left and right turns. Assumed a 40/35/25 split (right to left) for lane utilization. $V_o = 12 + 1471(0.40 + 0.35) + 33 = 1148$

1148

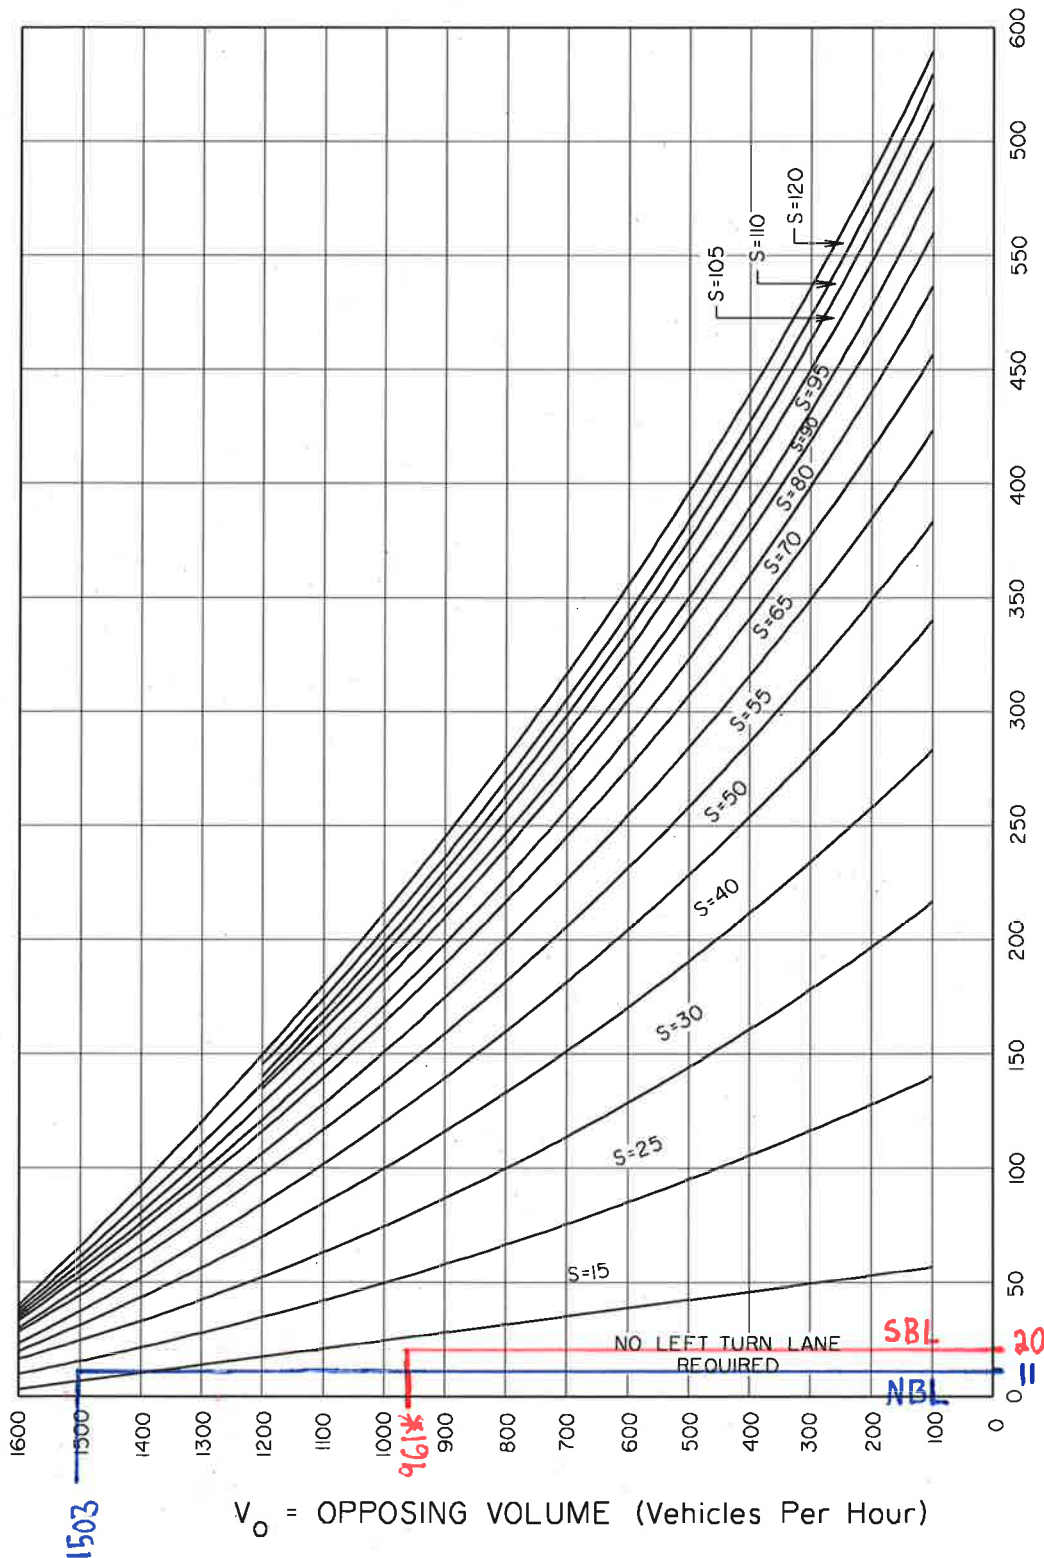
FIGURE D-8.6c WARRANTS FOR LEFT TURN LANES AND STORAGE REQUIREMENTS FOR FOUR-LANE DIVIDED HIGHWAYS

* Adjusted opposing volume for SBL in same manner as described for AM 100th Highest Hour analysis.

$$V_o = 11 + 12.46(0.40 + 0.35) + 15 = 961$$
